Title:	Plates are not put correctly on Transfer Station	ID:	
		0308	
Date in:	Response:	Model:	Author:
2008-01-15	2008-01-157	-	CMa

Slide Station Horizontal Position Adjustment

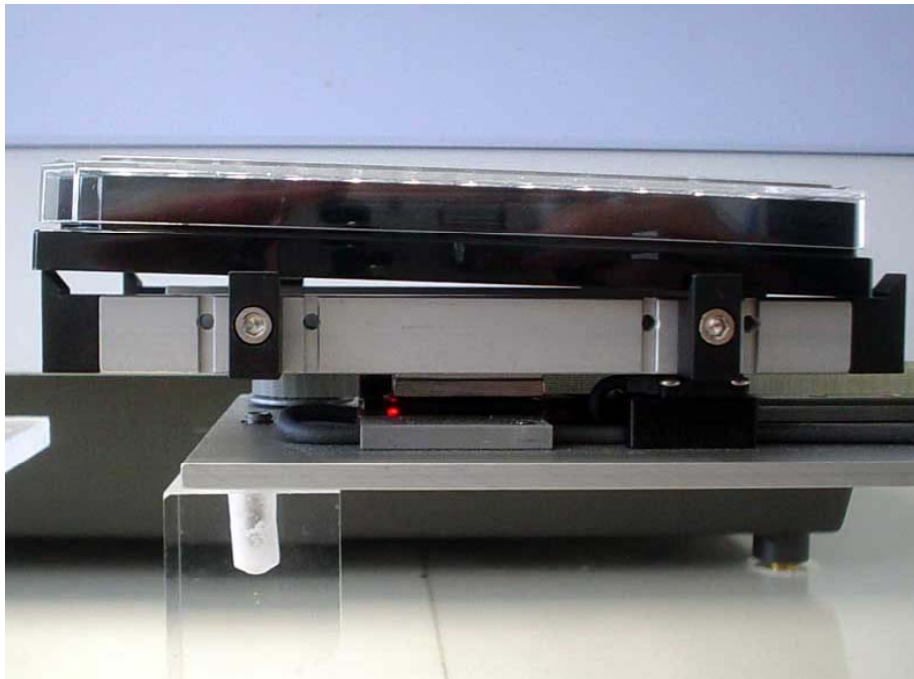
Error: The plate is put to far out.

The inner position of the Slide Station is to close to the back plane or the Gate Most likely the machine was pushed inwards.
