Title:	STX1000 Lifter TPM Connector			ID:
				0021
Date in:	Response:	Model:	Author:	
2007-06-12	2007-06-12	STP1000	CMa

STP1000-DFSA Former Lifter / TPM Connector

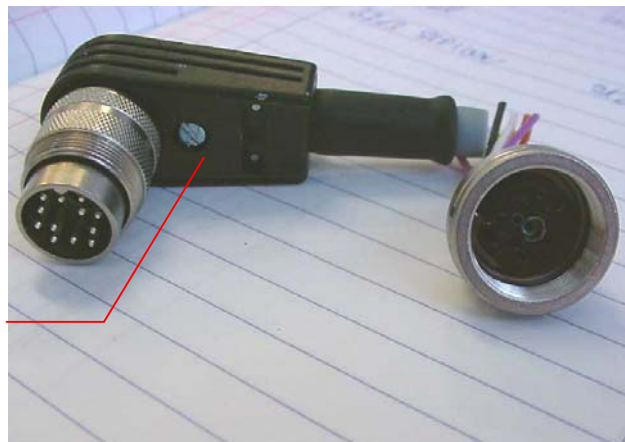
1st series Lifter Connector (must be replaced)

Attached pictures show lifter resp. TPM connector of early STX1000-DFSA systems. These type connectors were replaced. All units should have these connectors replaced since operation with old connectors may cause unreliable operation.

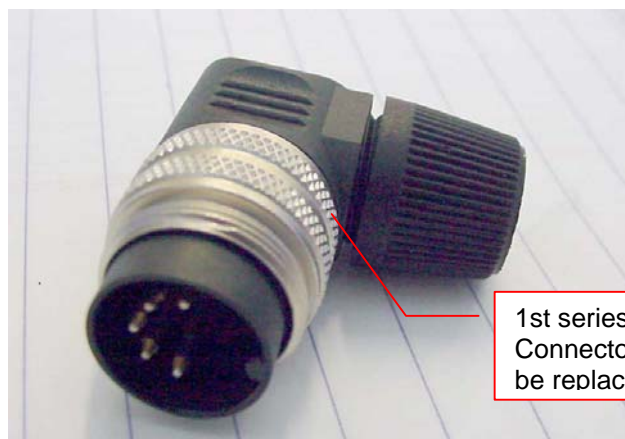
1st series TPM Connector (must be replaced)

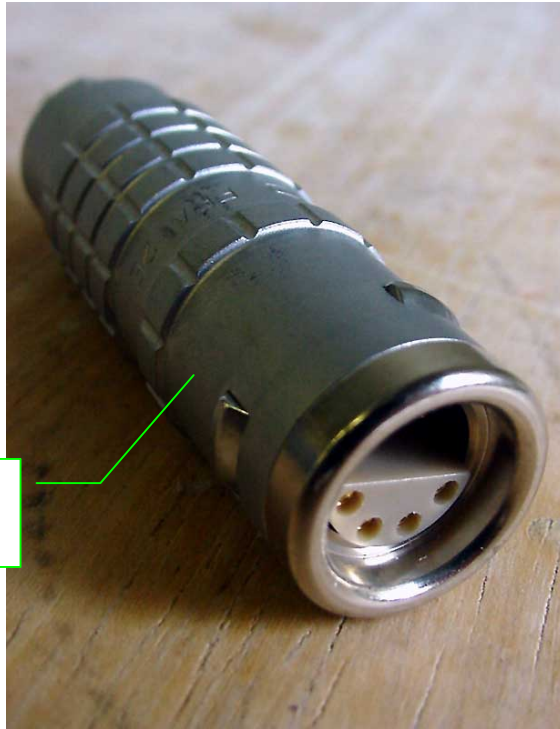
New / Current
Lifter / TPM
Connector
